Kodak DryView
8900 LASER IMAGER

Service Bulletins

Kodak DryView 8900 LASER IMAGER

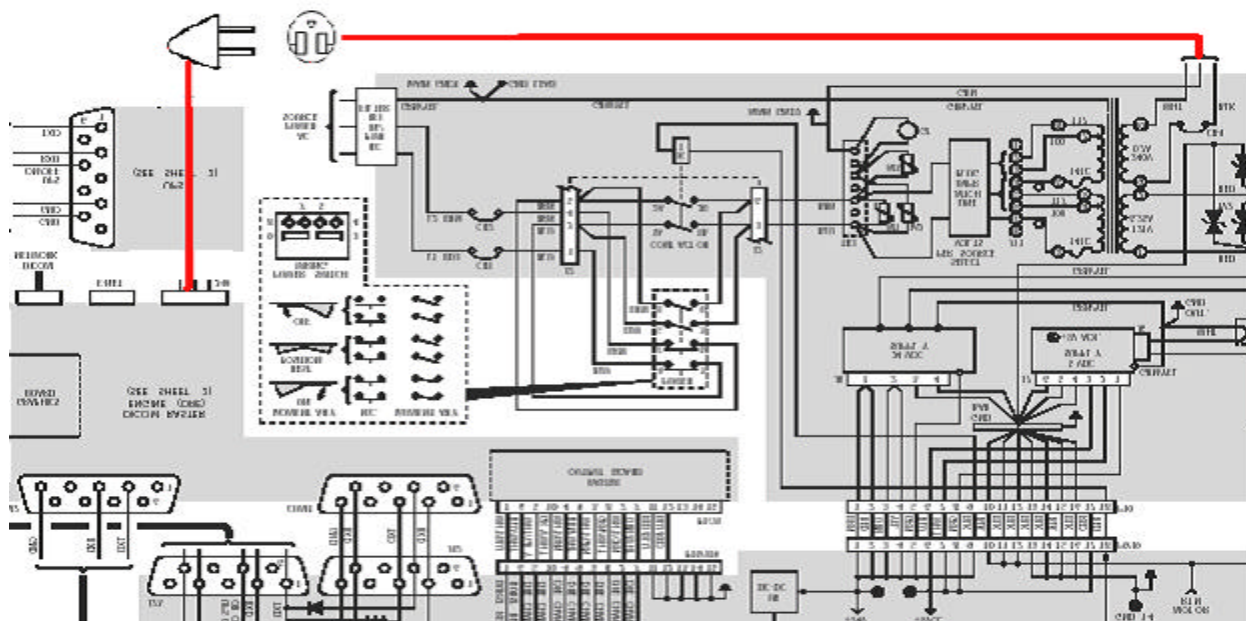
Several POWER MODULE assemblies have been replaced in the field due to a failed UPS. With Release 2.11 software installed the UPS is no longer needed. The main purpose of the UPS was to perform a controlled shutdown of the DRE. Development has determined that with Release 2.11 software this controlled shutdown is not necessary, eliminating the need for the UPS.

1. Verify the EBA BOARD (SP8E1593) is at revision G or higher. If the EBA BOARD is a prior revision the system will not remain in the ON state because it requires communication with the UPS in order to hold the system energized.
2. Verify that the 8900 LASER IMAGER has been upgraded to at least Release 2.11 software.
3. Divert power from the UPS by disconnecting the incoming line voltage from the secondary windings that feed the UPS and connect it directly to the POWER CORD that feeds the DRE as depicted in the drawing below.

The POWER CORD from the DRE can plug directly into the LINE CORD from the secondary tap of the POWER MODULE TRANSFORMER.

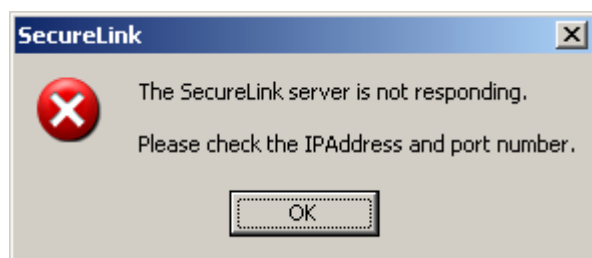
Symptom: While attempting to connect to the service port of the *Kodak DryView* 8900 LASER IMAGER using *Kodak SECURE LINK SERVER SOFTWARE*, the following error occurs:

Possible Cause: *Microsoft* INTERNET EXPLORER may attempt to use a proxy server to connect to the service port. The default setting is for *Microsoft* INTERNET EXPLORER to bypass the proxy server when connecting to any local address; however, only host names (for example, <http://webserver>) are checked not specific IP addresses.

Resolution: Modify the proxy server settings to include the local address of the service port.

1. In *Microsoft* INTERNET EXPLORER, on the '**Tools**' menu, click '**Internet Options**'.
2. On the '**Connections**' tab, click '**LAN Settings**'.
3. Make sure the '**Automatically detect settings**' and '**Use automatic configuration script**' boxes are not selected.
4. If the '**Advanced**' button is disabled (grayed out), click the '**Use a proxy server for your LAN**' box to enable it.
5. Click '**Advanced**' and type localhost;192.168.0.1 in the '**Exceptions**' area (don't forget the semicolon). Click **OK**.
6. Uncheck the '**Use a proxy server for your LAN**' box.

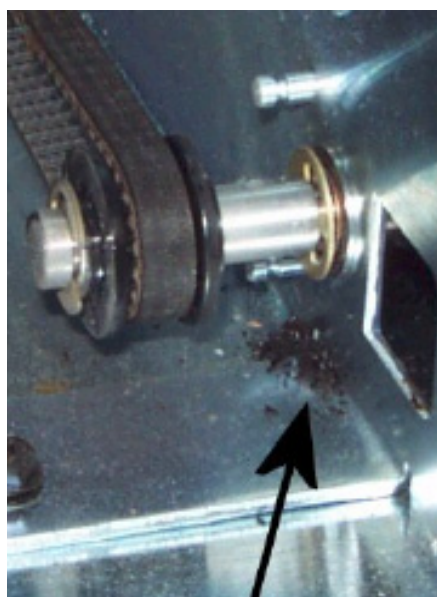
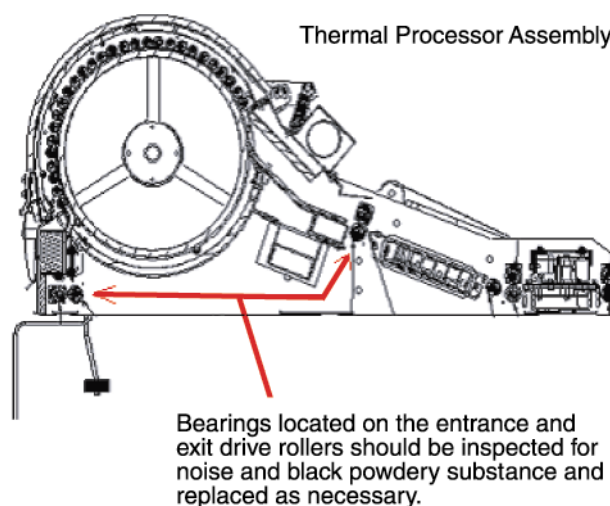
Be advised that Design has identified and Field Service has verified the potential of a premature bearing failure in the *Kodak DryView 8900 LASER IMAGER*. The identified bearing (Part Number SP6E8804) is used throughout the machine; but to date, the failure has been isolated to two locations in the Thermal Processor Assembly as identified in the image below. These locations are introduced to small amounts of FAZ, operate at a slightly higher temperature, and operate at a higher radial load due to the drive train.

Symptoms of a failing bearing are deposits of a black powdery substance below the affected bearing (see image below) and/or a high frequency noise emanating from the Thermal Processor Assembly.

A new bearing design has been implemented (changed lubricant) and is available in Spares (Part Number SP5F2063). On a next call basis, close inspection of all bearings in the Thermal Processor Assembly) is advisable. Machine Serial Number effectivity for the use of the new bearing design is 890002262. A minimum quantity of five of the new bearings should be maintained in all field service custody.

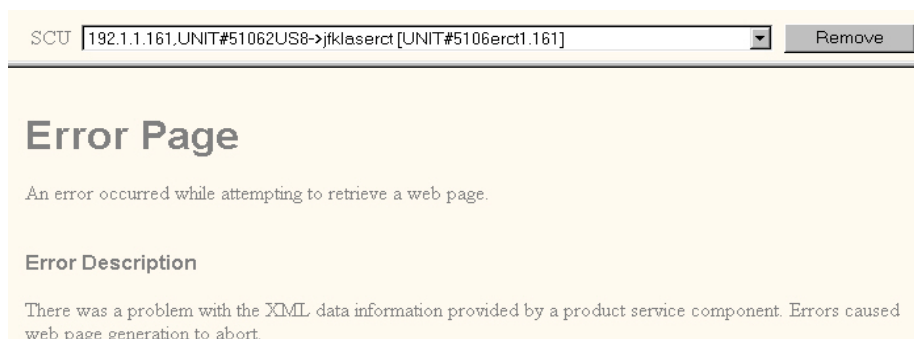
The purpose of this Service Bulletin is to communicate an issue in regards to characters in an SCU modality AE Title that may cause the SERVICE TOOL to display the following error when attempting to configure an SCU modality.

The SCU modality will be able to send print requests to the 8900 LASER IMAGER, but the IMAGER will use the default parameter settings for “Image Optimization” and “Other” settings. If the AE Title of an SCU modality contains any of the characters listed above and that SCU is selected to perform image optimization, the SERVICE TOOL will issue the above error condition. When this Error Page is displayed, the SCU AE Title cannot be removed and the Backup function will not work.

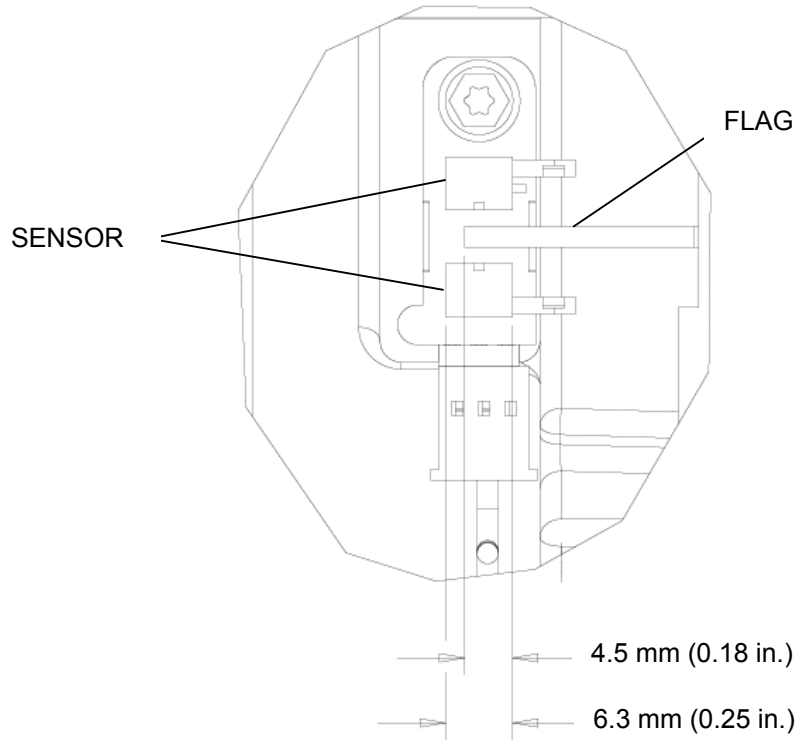
Figure 5. Horizontal Position of FLAG with Respect to SENSOR in Home Position

With mechanism in mechanical Home position, position of FLAG with respect to SENSOR = 45/63 (about 70% but not less than 70%).
